Aircraft
Specialties Co.**SERVICE BULLETIN NO. 1**

PART NAME: Air Filter Assembly
PART NUMBER: BA-8110 (With Welded in Retainer)
STC NUMBER: STC - SA71GL

SERVICE BULLETIN NO. 3

PART NAME: Air Filter Assembly
 PART NUMBERS: BA-4106, BA-4210, BA-5110, BA-6110, BA-8110
 STC NUMBER: STC-SA71GL

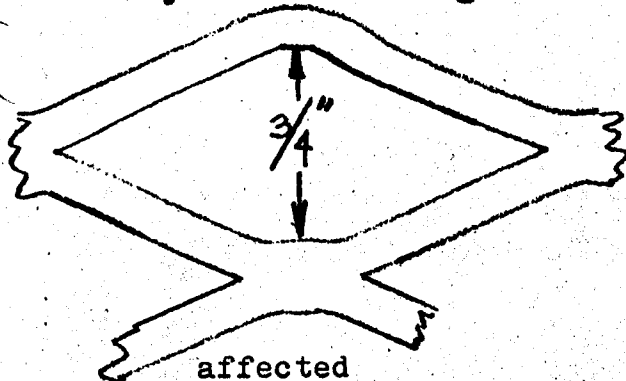
INSPECTION: Remove element and inspect retainer. If retainer has large
aluminum diamond shaped opening 1-3/4" x 3/4" (ones that you can
stick your finger through), then the filter assembly is affected
by this bulleting.

STEEL this type screen
is not affected by bulletin

COMPLIANCE: Order Kit that corresponds to affected filter assembly.
